AUSTRALAND THE CARLTON REFUGE CARLTON VICTORIA

*Queen Elizabeth Maternal
and Child Health Centre*

COMPLETION: APRIL 2014
INVESTMENT: \$<.7M

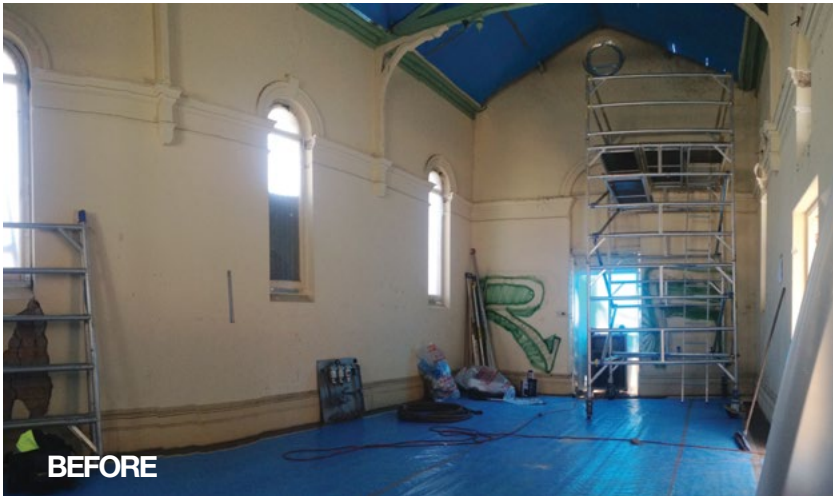
BEFORE

The removal of friable asbestos contaminated render to heritage listed buildings was conducted over a tight three month program, including;

- Extensive encapsulation to all asbestos containing buildings on site
- Removal of thousands of m² of asbestos contaminated render under friable conditions
- Removal of chemically contaminated asbestos soil

To ensure asbestos contaminated render was removed from the heritage brickwork in its entirety without any damage to structure or heritage bricks.

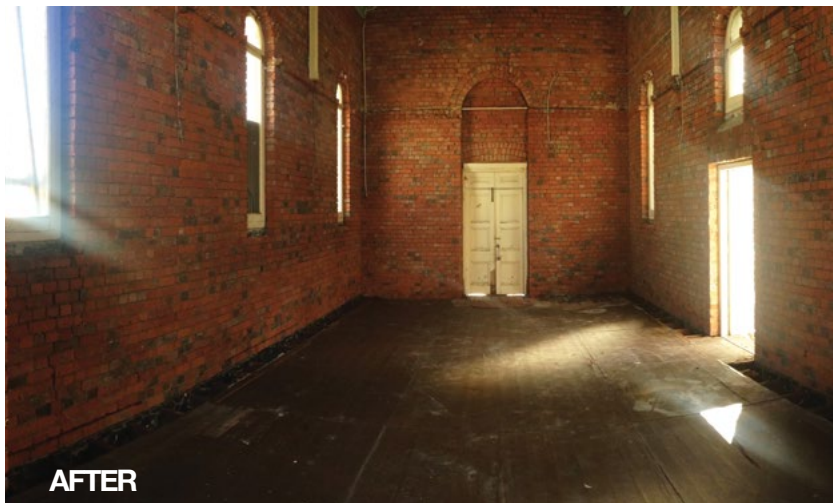
AFTER

AAH CONTRACTING WAS ALSO ABLE TO CONDUCT THE ASBESTOS REMOVAL WITHOUT ANY DAMAGE TO HERITAGE SURFACES WHATSOEVER, INCLUDING THE DISCOVERY AND RESTORATION OF SENSITIVE HANDMADE 18TH CENTURY MUD BRICKS, WHICH WERE SUBSEQUENTLY RETURNED TO THEIR FORMER GLORY.

Incorporating new removal technology that strips heritage bricks without damaging them. New specialist pneumatic technology was imported and utilised specifically for this project.

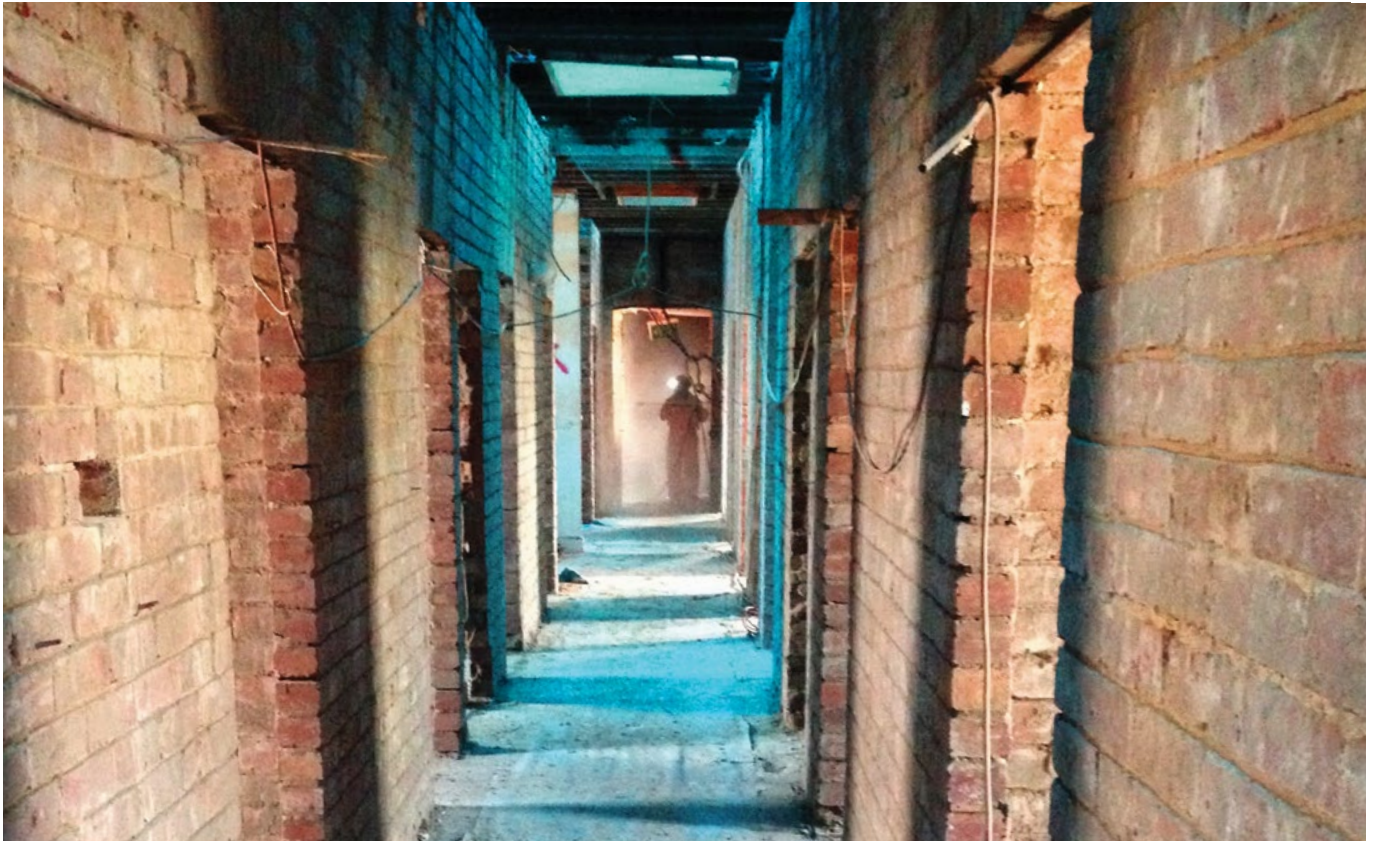
The work involved the extensive encapsulation of the entire buildings. In order to obtain a negative pressure environment an entire temporary sealed roof was devised, constructed and installed to several buildings within the site, without damage to the existing façade.
